# Manhole Inspection Summary

Manhole # S19I\_\_041MH

Insp Date: **2/29/08 12:54 PM**

**Location** Address: **16 calverton st**

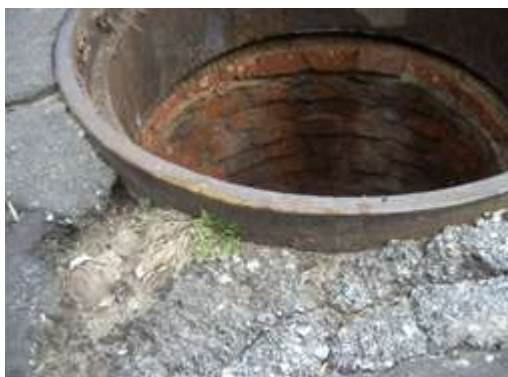
Misc

Diameter: **24** (in.) Length: **0** (in.) Dist A/B Grade: **2** (in.)

above grade

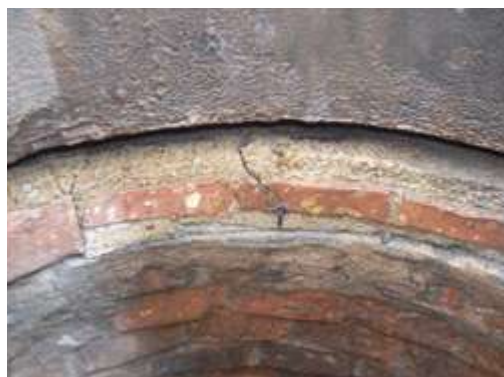
Defect 5

Condition: ☐ Sound ☒ **Cracked** ☐ Root Intrusion ☐ Loose Brick ☐ Deteriorated

cracked chimney

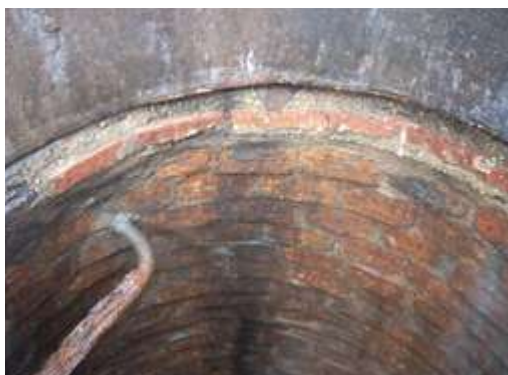
Defect 4

Infiltration: ☐ None ☐ Joint ☐ Cracks ☐ Mortar ☐ Roots ☒ **Wall**

infiltration of the corbel wall

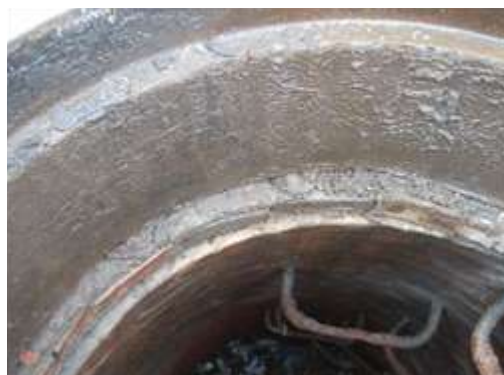
Defect 3

Offset: **2** (in.)

frame offset

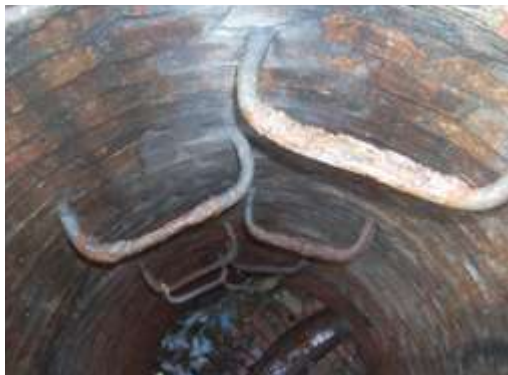
### Defect 2

Count: **7** Missing: **0** ☒ **Corroded**

corroded steps

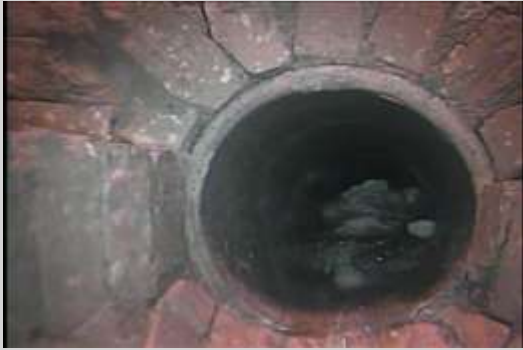
9 O'Clock Inflow

Deposits: ☐ None ☐ Mud ☐ Sludge ☒ **Debris** ☐ Grease

Silt Depth: **2** (in.) Deposits Extent: **Light**
